# Marshall Islands Dose Assessment and Radioecology Program

## 2018 Visual Study Report on the Cactus Crater Containment Structure: Supplement to Webpage Reporting

June 2021

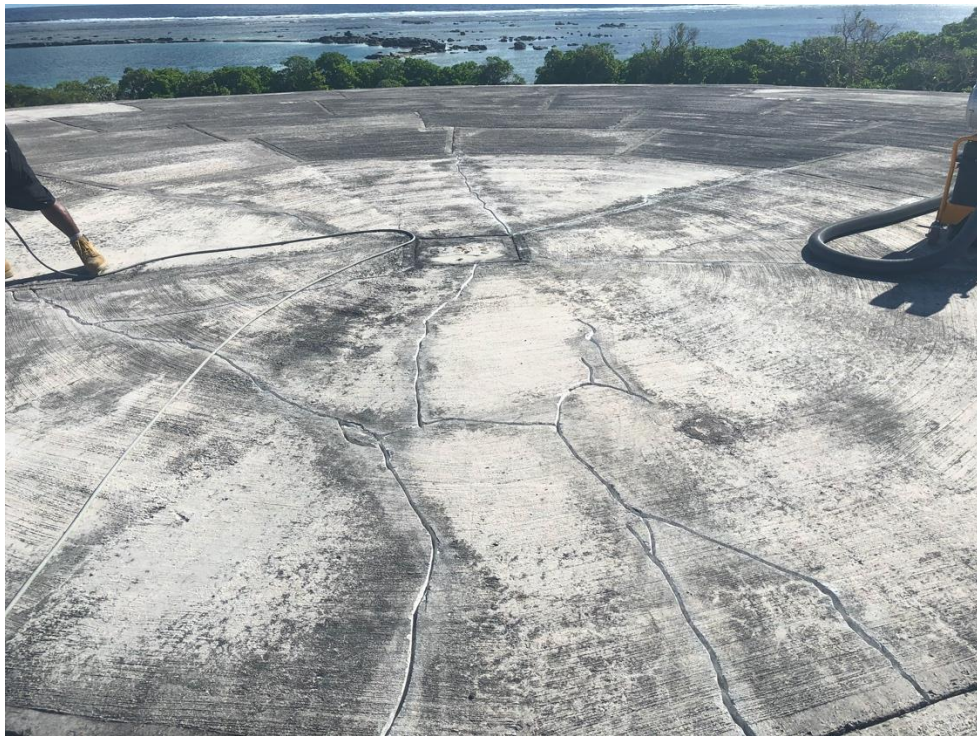
**Fig 4a.** Repair Operations Topcap Section of the Cactus Crater Containment Structure  
(*showing the machine cut out of the cracks prior to filling with epoxy*)  
(October 2018)

About 1,070 feet of crack was machine cut and filled with epoxy resin. There is about 1,128 feet of crack remaining across 35 different panels still in need of repair (Per comm, Jim Powers, CEL Inc). Example photos of the steps taken to repair the crack are given in **Fig. 4 a & b**.

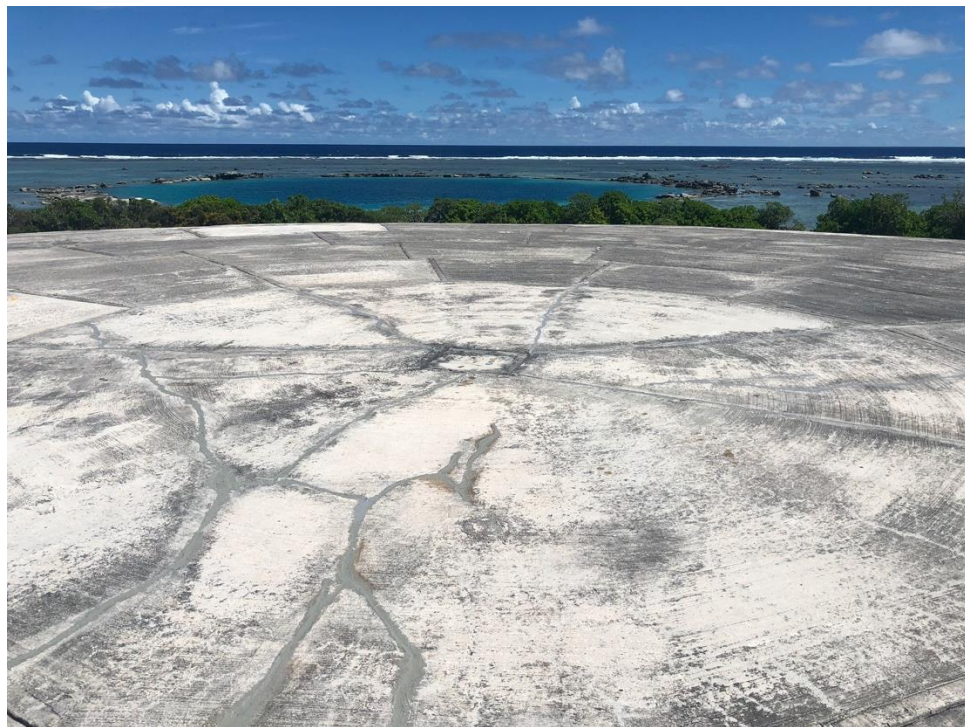
**Fig 4b.** Repair Operations Topcap Section of the Cactus Crater Containment Structure  
(*showing the machine cutout of cracks filled with epoxy*)  
(October 2018).

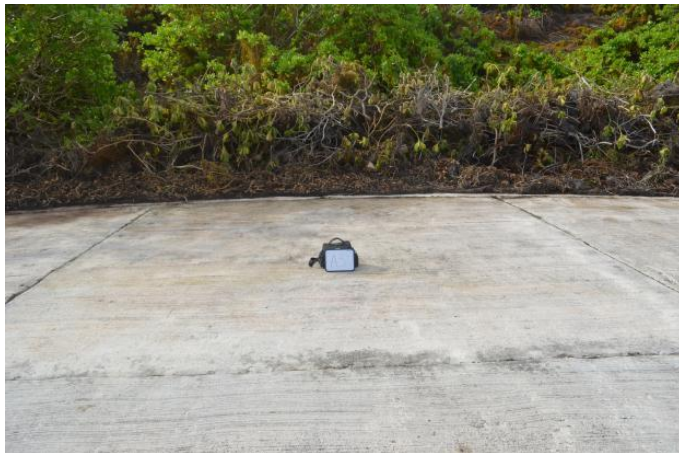
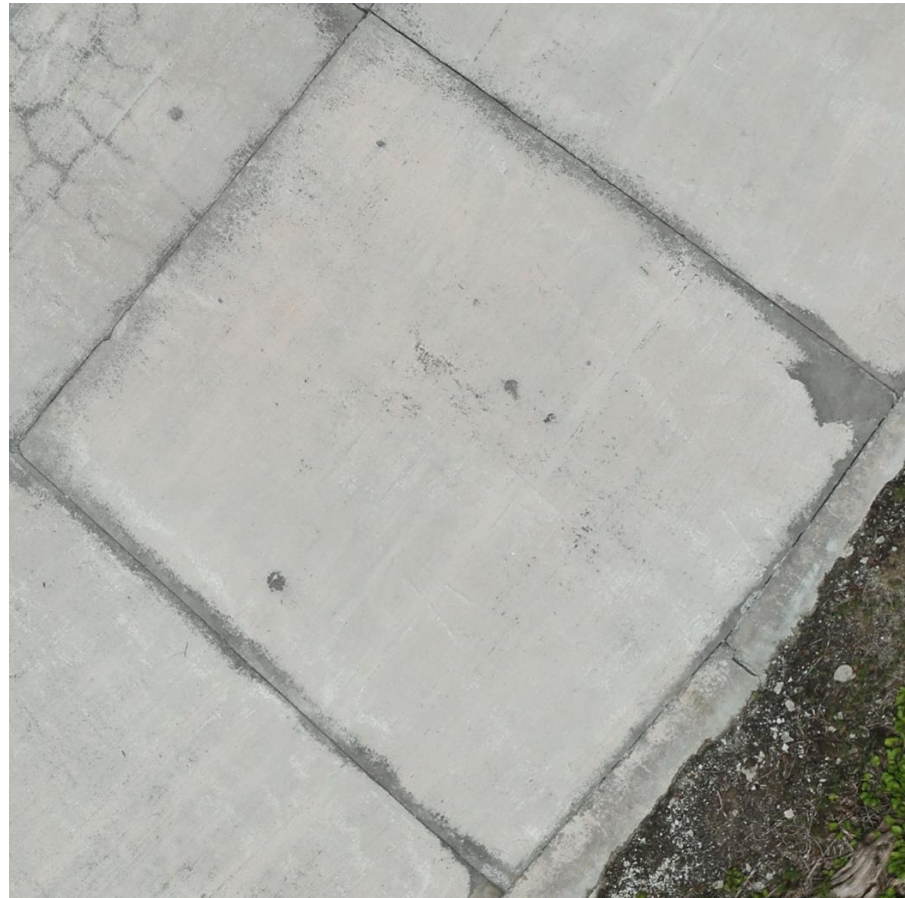
2013. No significant or obvious interior cracks extending across the top of the panel. Minor spalling of concrete observed in the top and bottom left-hand corners, and in the bottom right-hand corner, of the panel.

2018. No significant changes in the condition of the concrete.

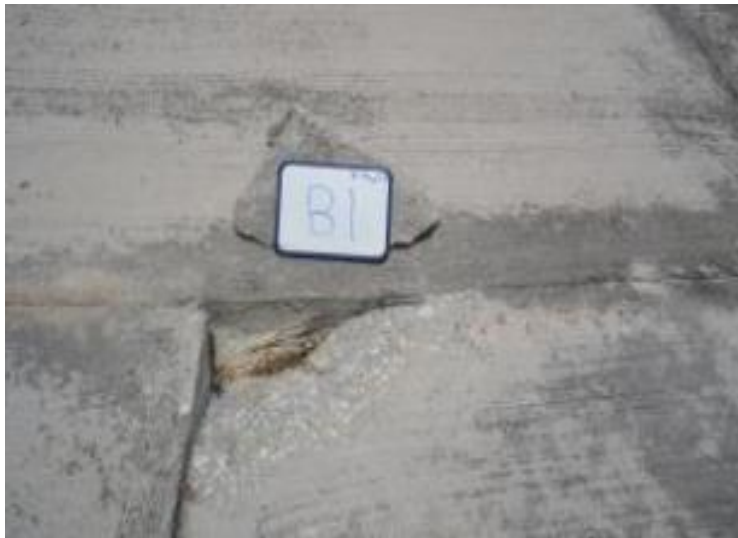
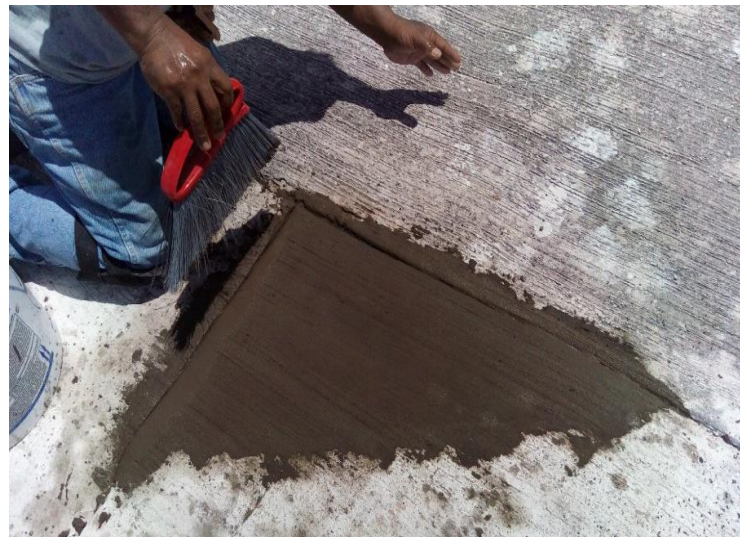
## **Panel B1**

2013. Significant spalling of concrete observed in upper right corner where the chipped-out piece of concrete extends down to contaminated soil – cement grout waste pile mixture below. Surface crack observed running across the full width of the panel at a mid-point up the segment. Rooting vegetation removed from along the panel seams. Panel recommended for priority repair.

2015. Repaired spalled patch of concrete. No significant changes in the condition of the concrete observed during 2018.

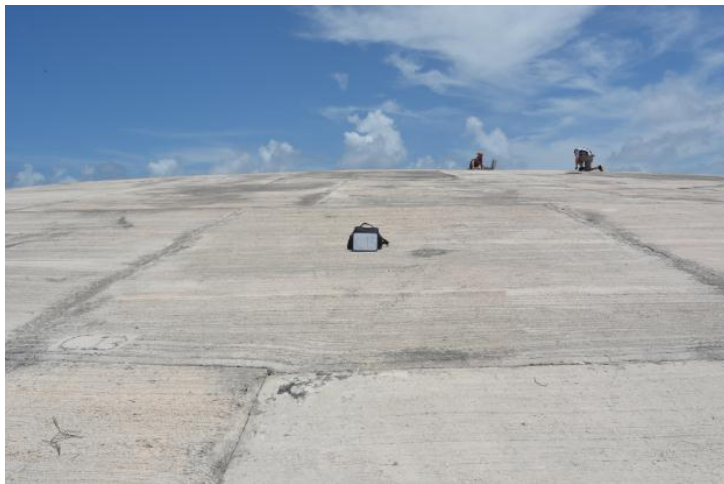
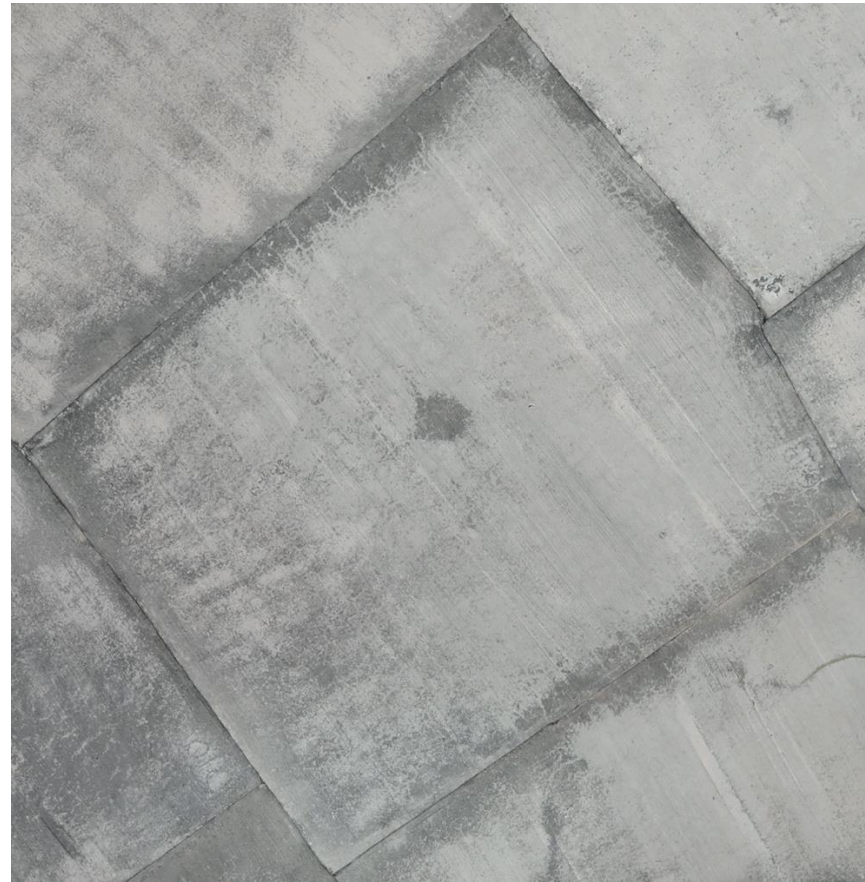
## Panel C13

2013. No significant or obvious interior cracks extending across the top of the panel. The panel has a rough and weathered appearance.

2018. No significant changes in the condition of the concrete.

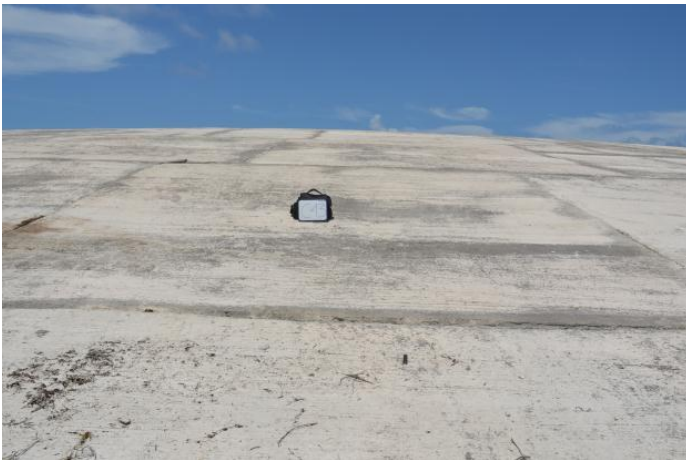
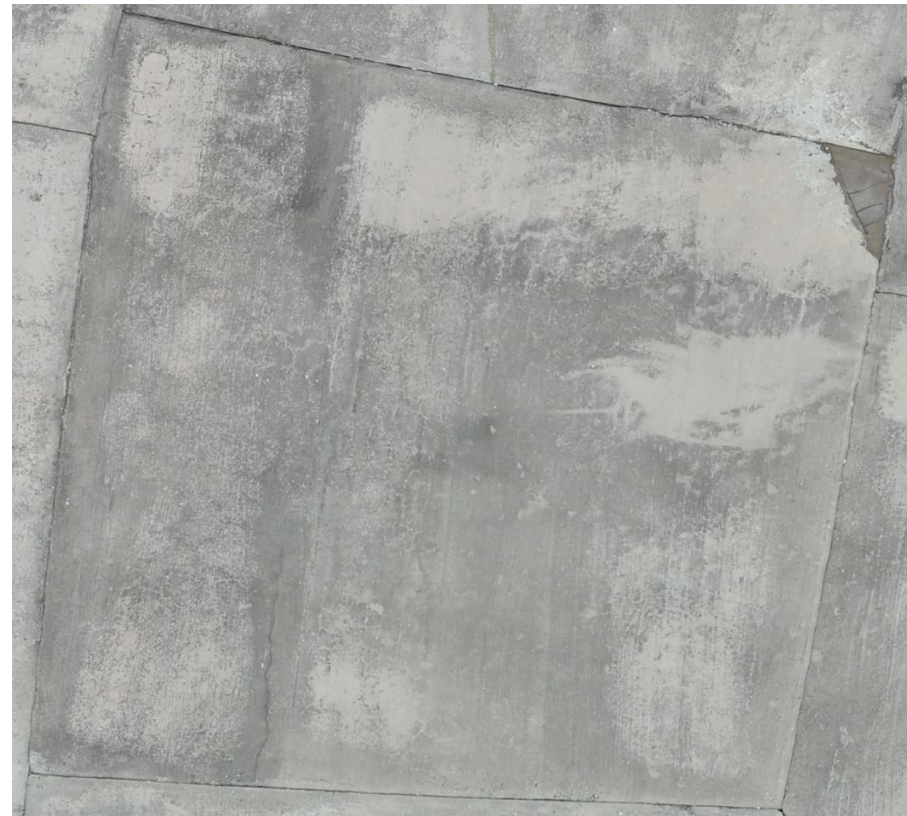
## Panel C 43

2013. Significant spalling of concrete observed in the upper left corner of the panel where the chipped-out piece of concrete extends down to contaminated soil-cement grout waste pile mixture below. Some minor spalling/cracking of concrete also observed in the lower right-hand corner of the panel. Panel recommended for priority repair.

2015. Spalled patch of concrete repaired. No significant changes in the condition of the concrete observed during 2018.

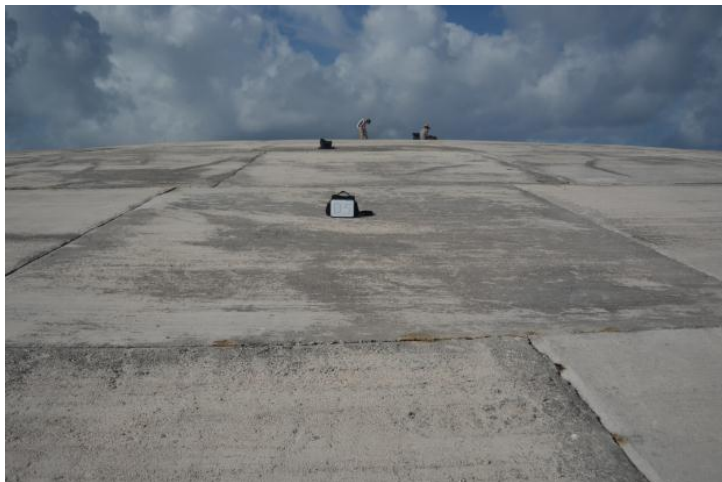
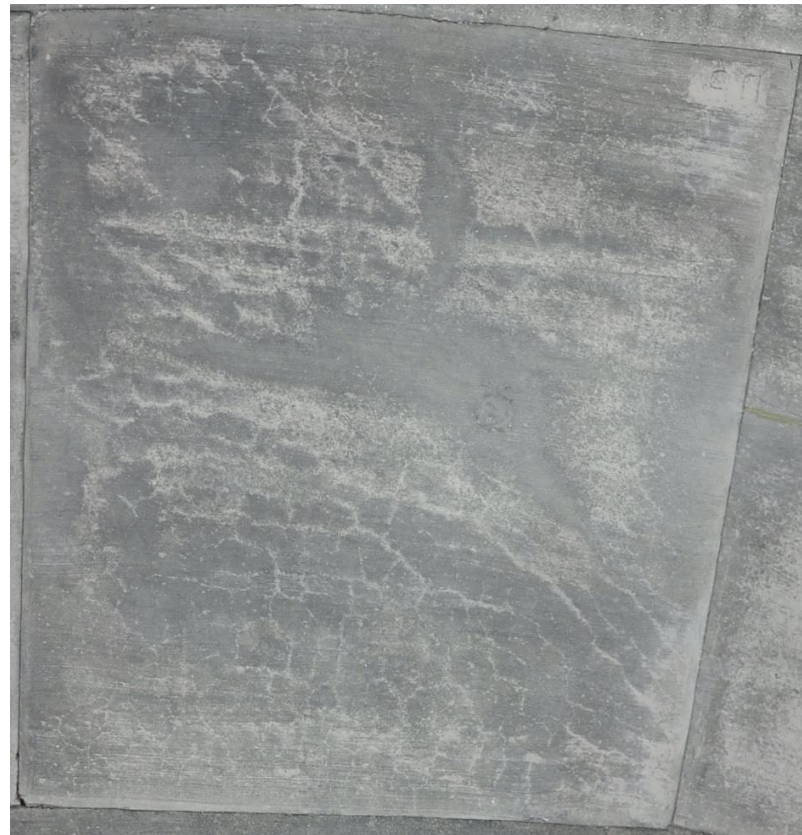
## Panel D5

2013. No significant or obvious interior cracks extending across the top of the panel. The panel has a rough and weathered appearance. Some spalling/cracking of concrete observed in the lower right-hand corner of the panel. Rooting vegetation removed from along the panel seams. Panel contains a filled concrete borehole (CD-1) from the 1980 NAS investigation.

2018. No significant changes in the condition of the concrete.

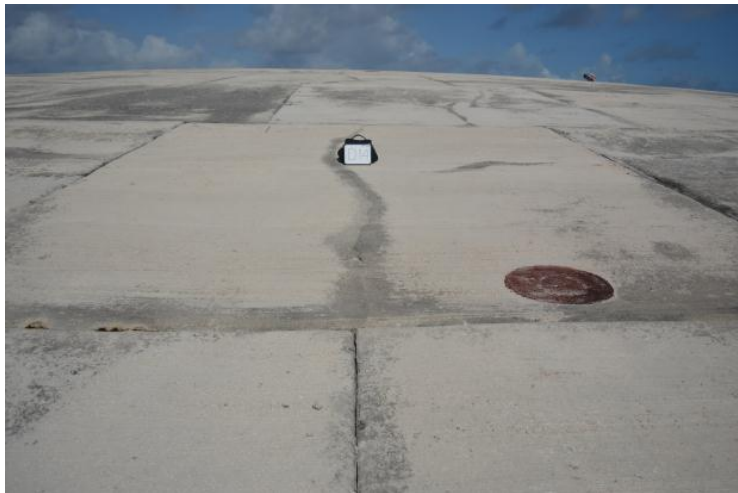
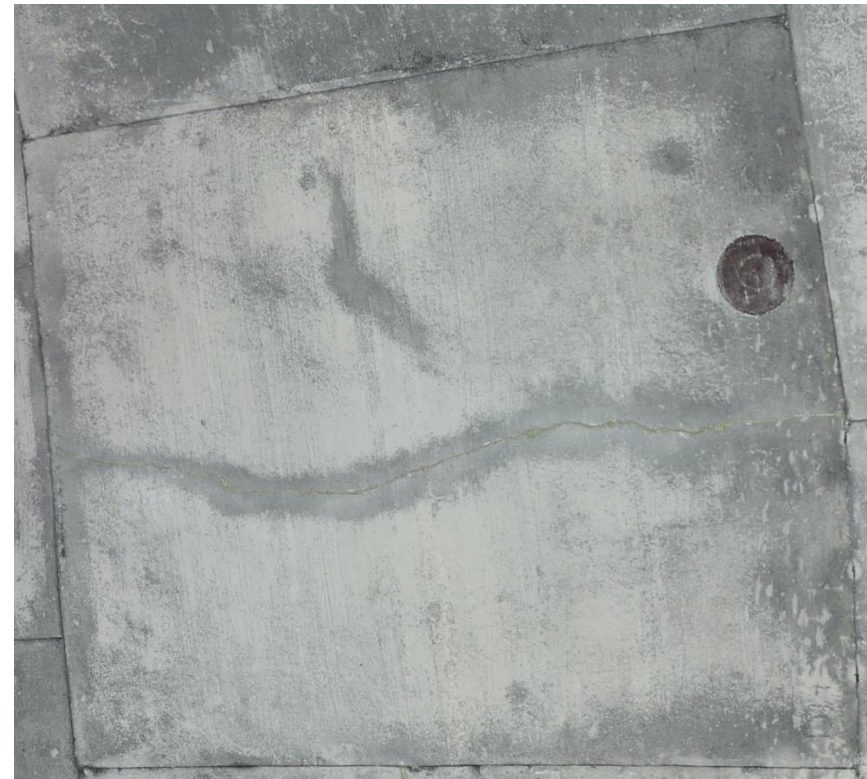
## Panel D14

2013. The panel has a rough and weathered appearance. A surface crack observed extending up from bottom seam adjacent to the corner intersection C17/C18. Panel contains a vertical elevation benchmark.

2018. No significant changes in the condition of the concrete. 20 feet of pre-existing crack cut and filled with epoxy.

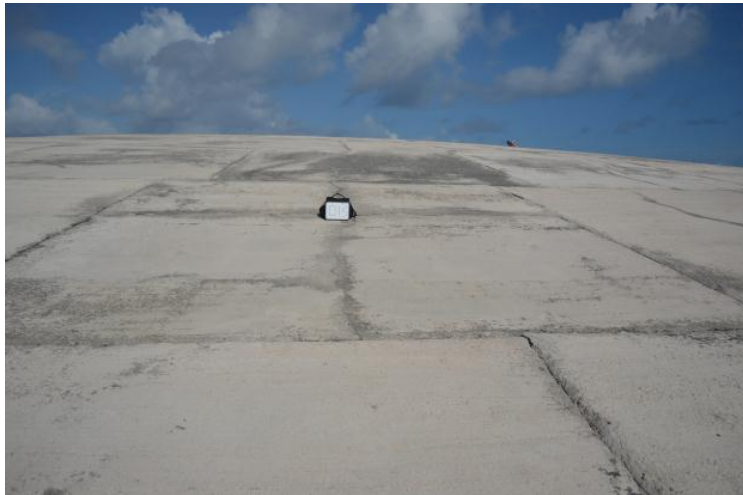
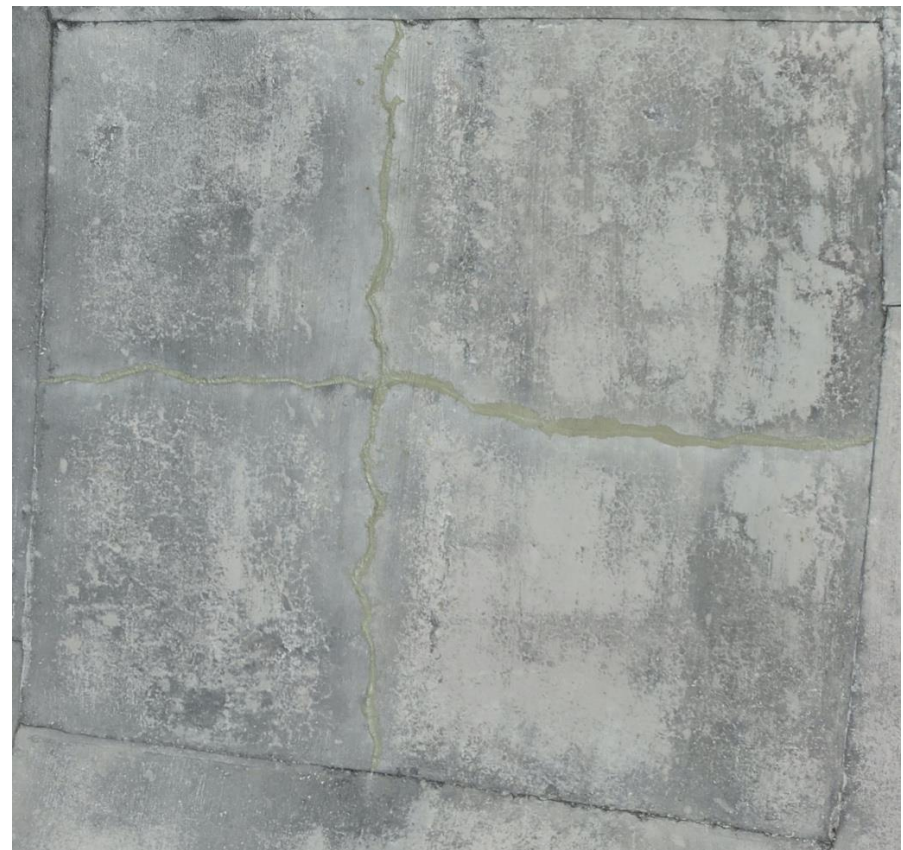
## Panel D15

2013. This panel contains the most severe crack of any segment on the dome. The crack width exceeds several millimeters in some areas and runs left to right at about a mid-point up the panel as well as up and down the panel from an intersection point in the middle. The crack contained chipped ‘spalled’ edges. Panel recommended for priority repair.

2018. No significant changes in the condition of the concrete. 38 feet of pre-existing crack cut and filled with epoxy.

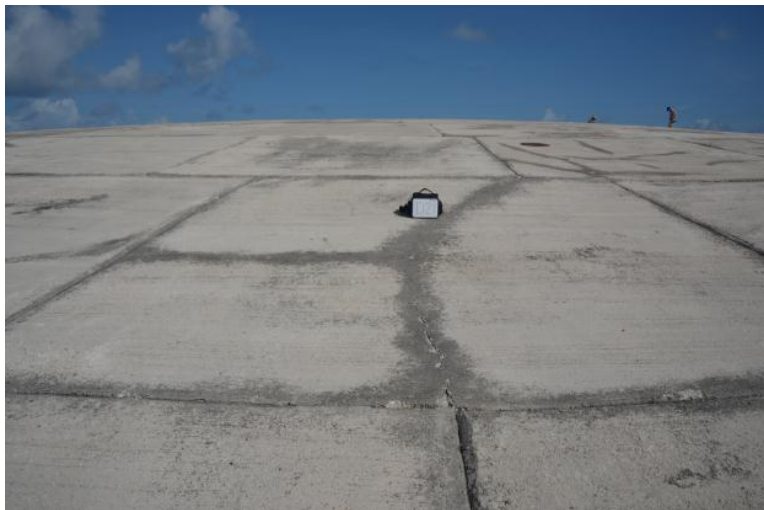
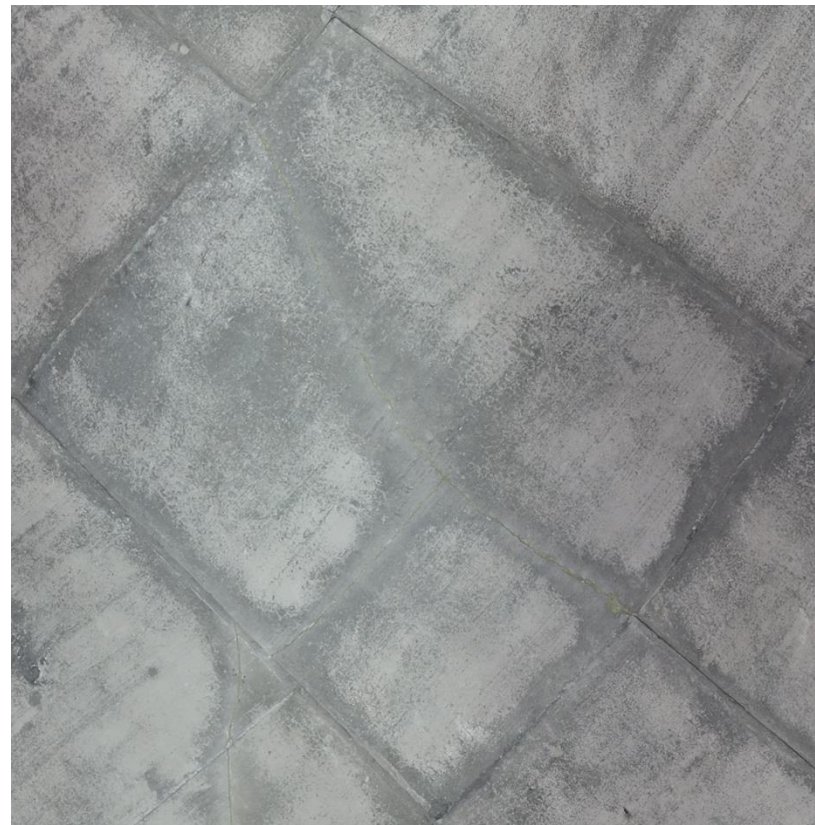
## Panel D21

2013. A crack observed extending upwards from a central position along the bottom seam adjacent to corner intersection C22/C23 and intersecting at corner E15/E16 on the ring row above. The crack branches out into a fork to the left edge at distances between 2 and 3 meters up from the base of the panel. The crack contains chipped ‘spalled’ edges. Panel recommended for priority repair.

2018. No significant changes in the condition of the concrete. 29 feet of pre-existing crack cut and filled with epoxy.

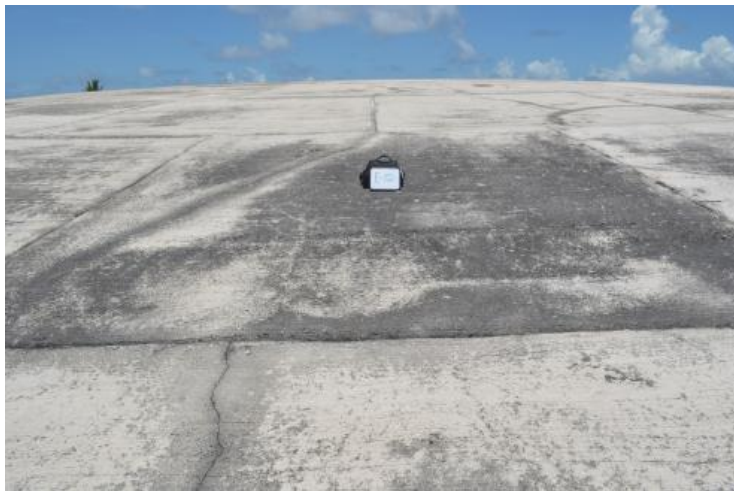
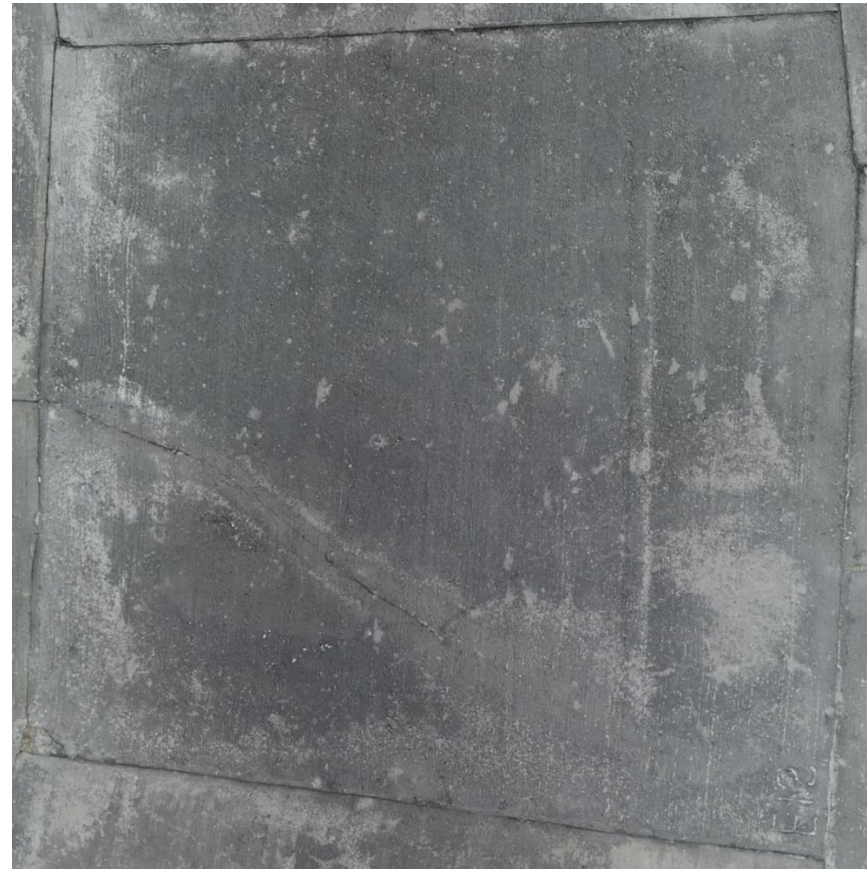
## Panel E12

2013. Panel has a rough and weathered appearance. Significant spalling/cracking of concrete observed in the upper left corner. The panel also contains a distinguishable crack extending up from the bottom left side of the panel and intersecting the upper seam at a position adjacent to the corner F9/F10 on the ring row above. Panel recommended for priority repair.

2018. No significant changes in the condition of the concrete. 30 feet of pre-existing crack cut and filled with epoxy.

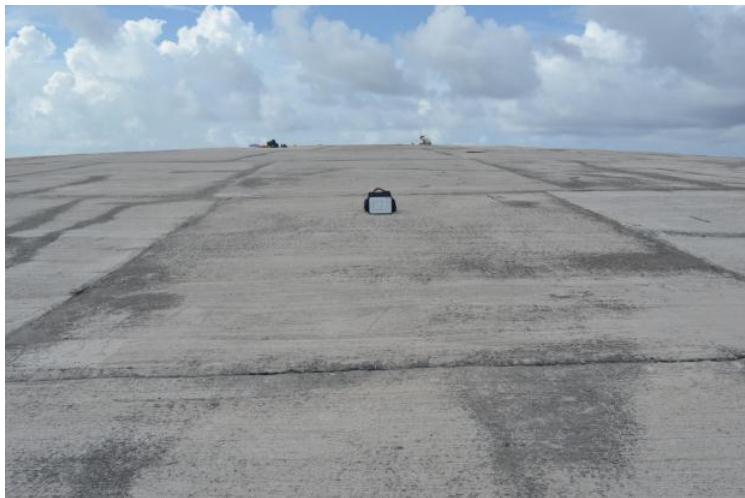
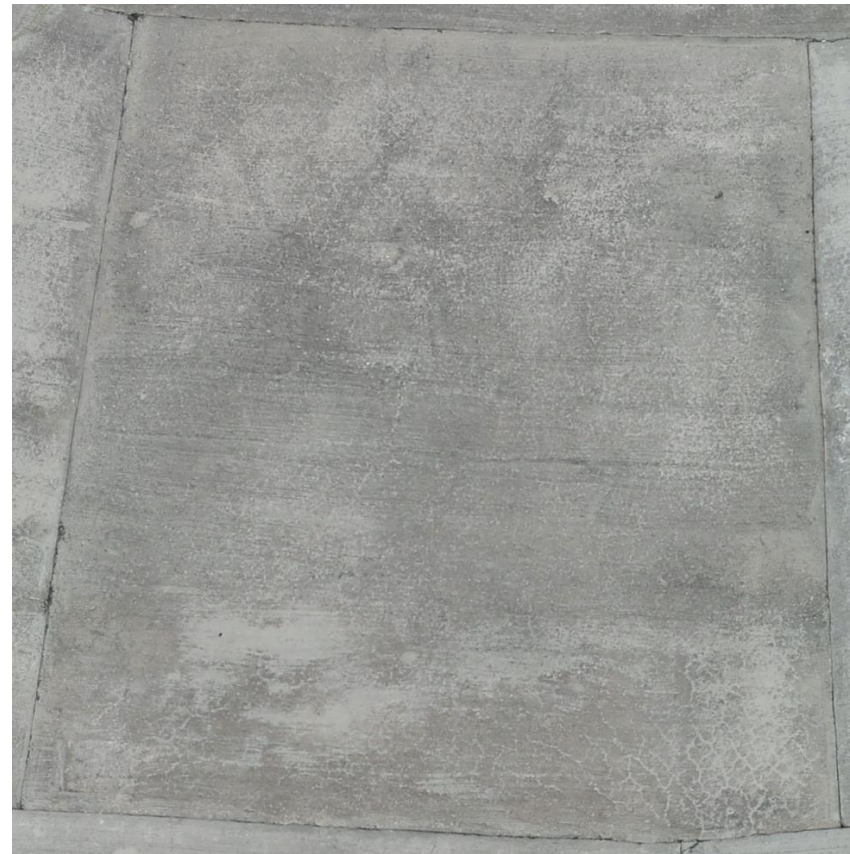
## Panel E21

2013. Some spalling/cracking of concrete observed in the upper left-hand corner of the panel. No obvious interior cracks or spalls extending across the top of the panel with exception of a small, voided piece of concrete in the upper right corner (app. 4 x 2-2.5 centimeters in area).  
2018. No significant changes in the condition of the concrete.

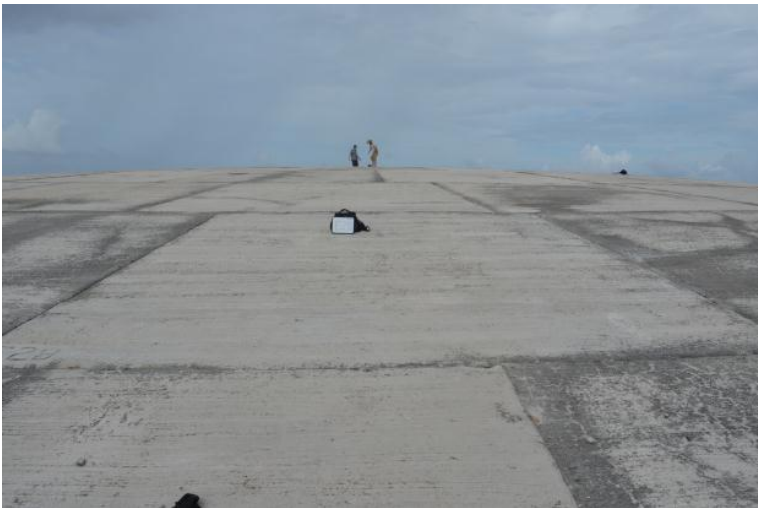
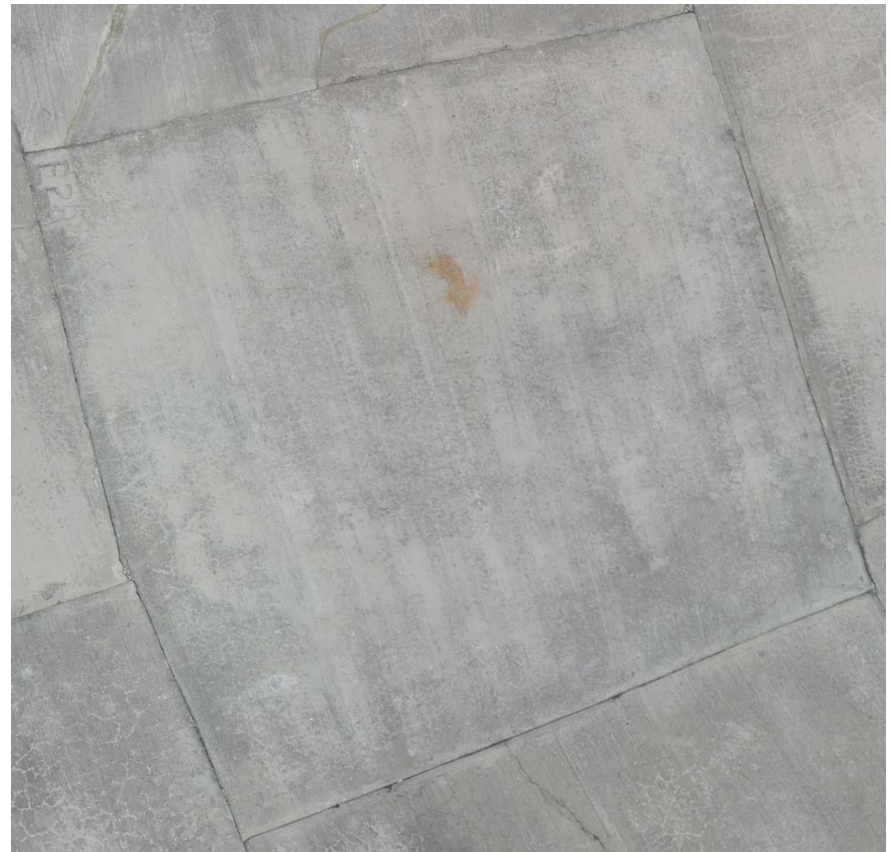
## Panel E28

2013. No significant or obvious interior cracks extending across the top of the panel. The panel has a rough and weathered appearance.

2018. No significant changes in the condition of the concrete.

Rooting vegetation removed from along the panel seams.

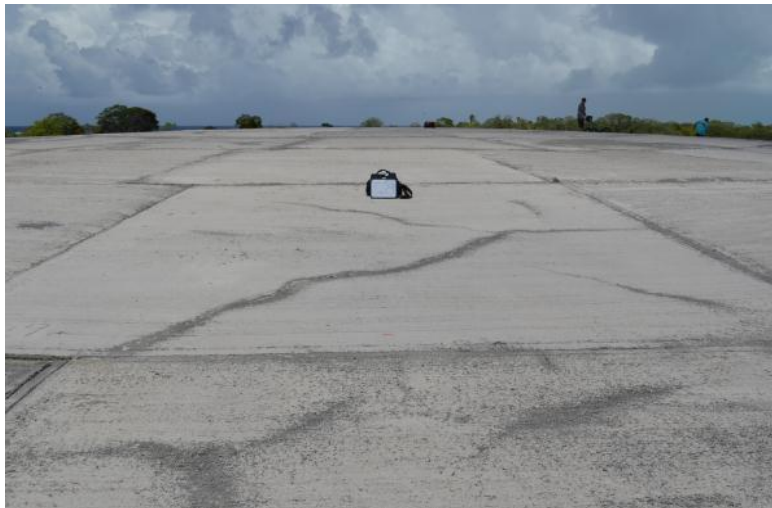
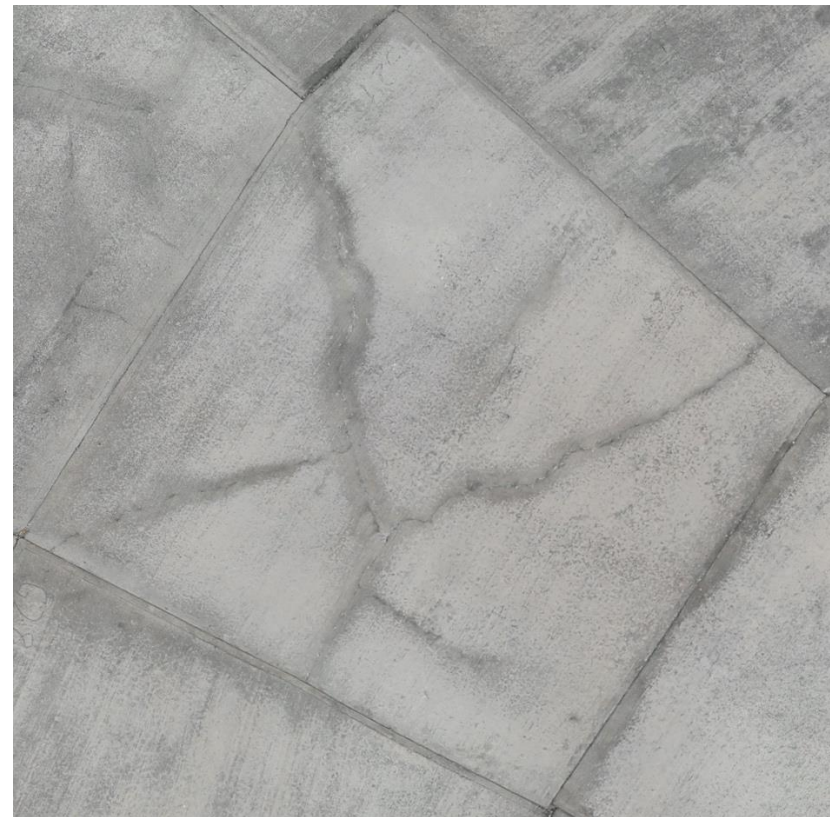
## Panel G29

2013. Surface crack observed extending up through the middle of the panel from the left side of the bottom seam towards the upper right-hand corner with forks branching out to the left and right sides at about a mid-point up the panel. Rooting vegetation removed from along the panel seams.

2018. No significant changes in the condition of the concrete. 38 feet of pre-existing crack cut and filled with epoxy.

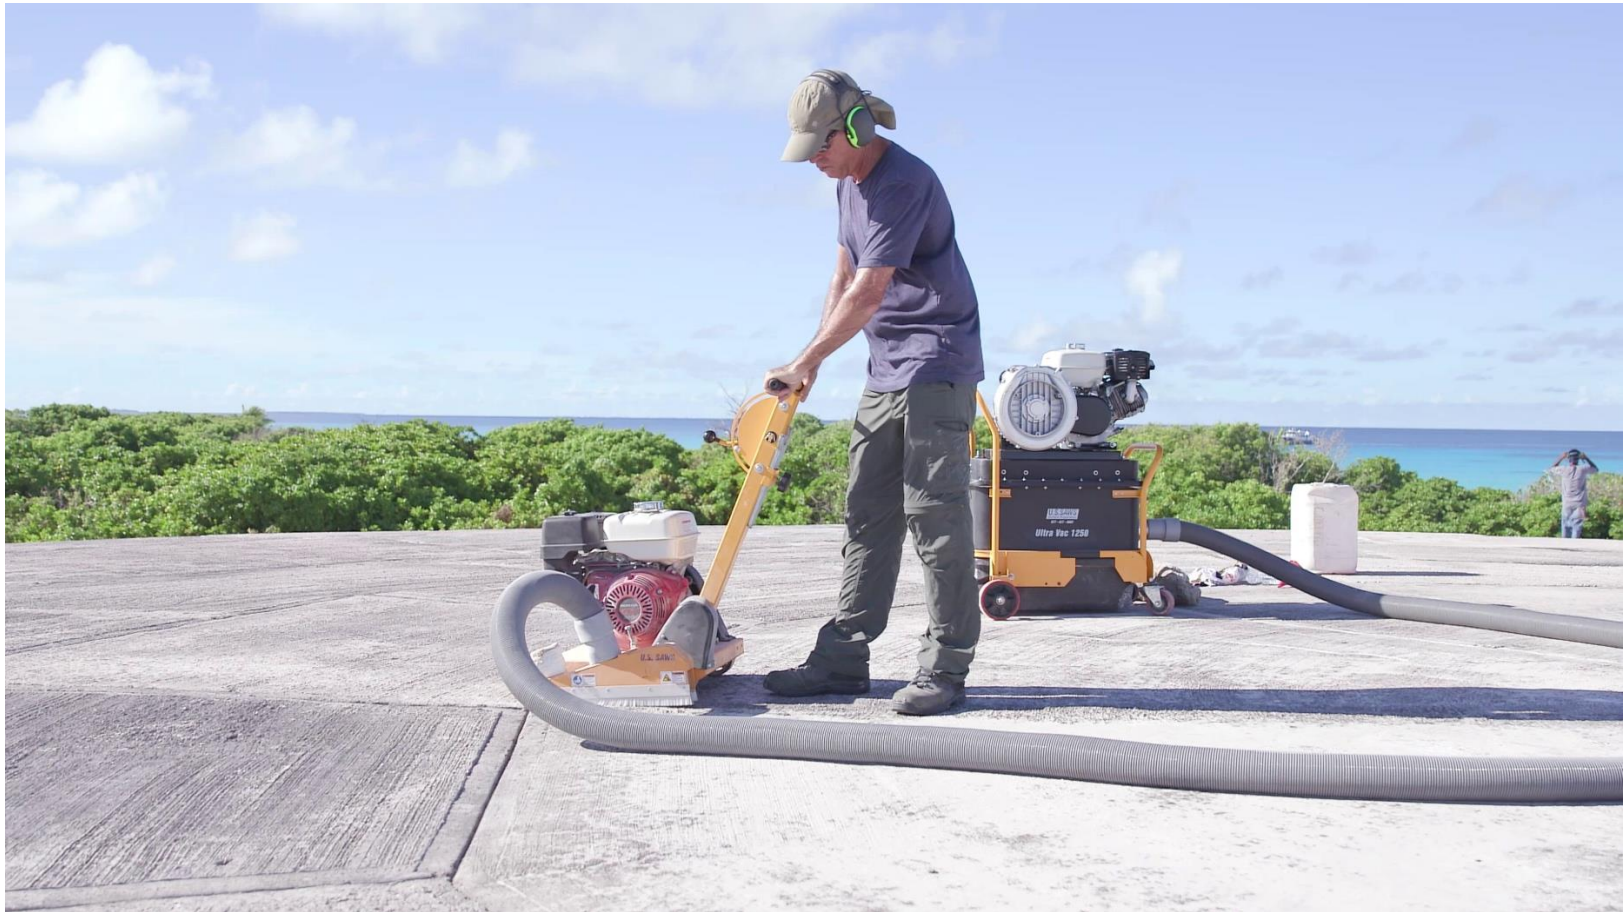
**Concrete Repair Operations Cactus Crater Containment Structure**  
**(CEL Licensed Engineer, Mr. Jim Powers)**  
**(October 2018)**  
***(Used with Permission)***

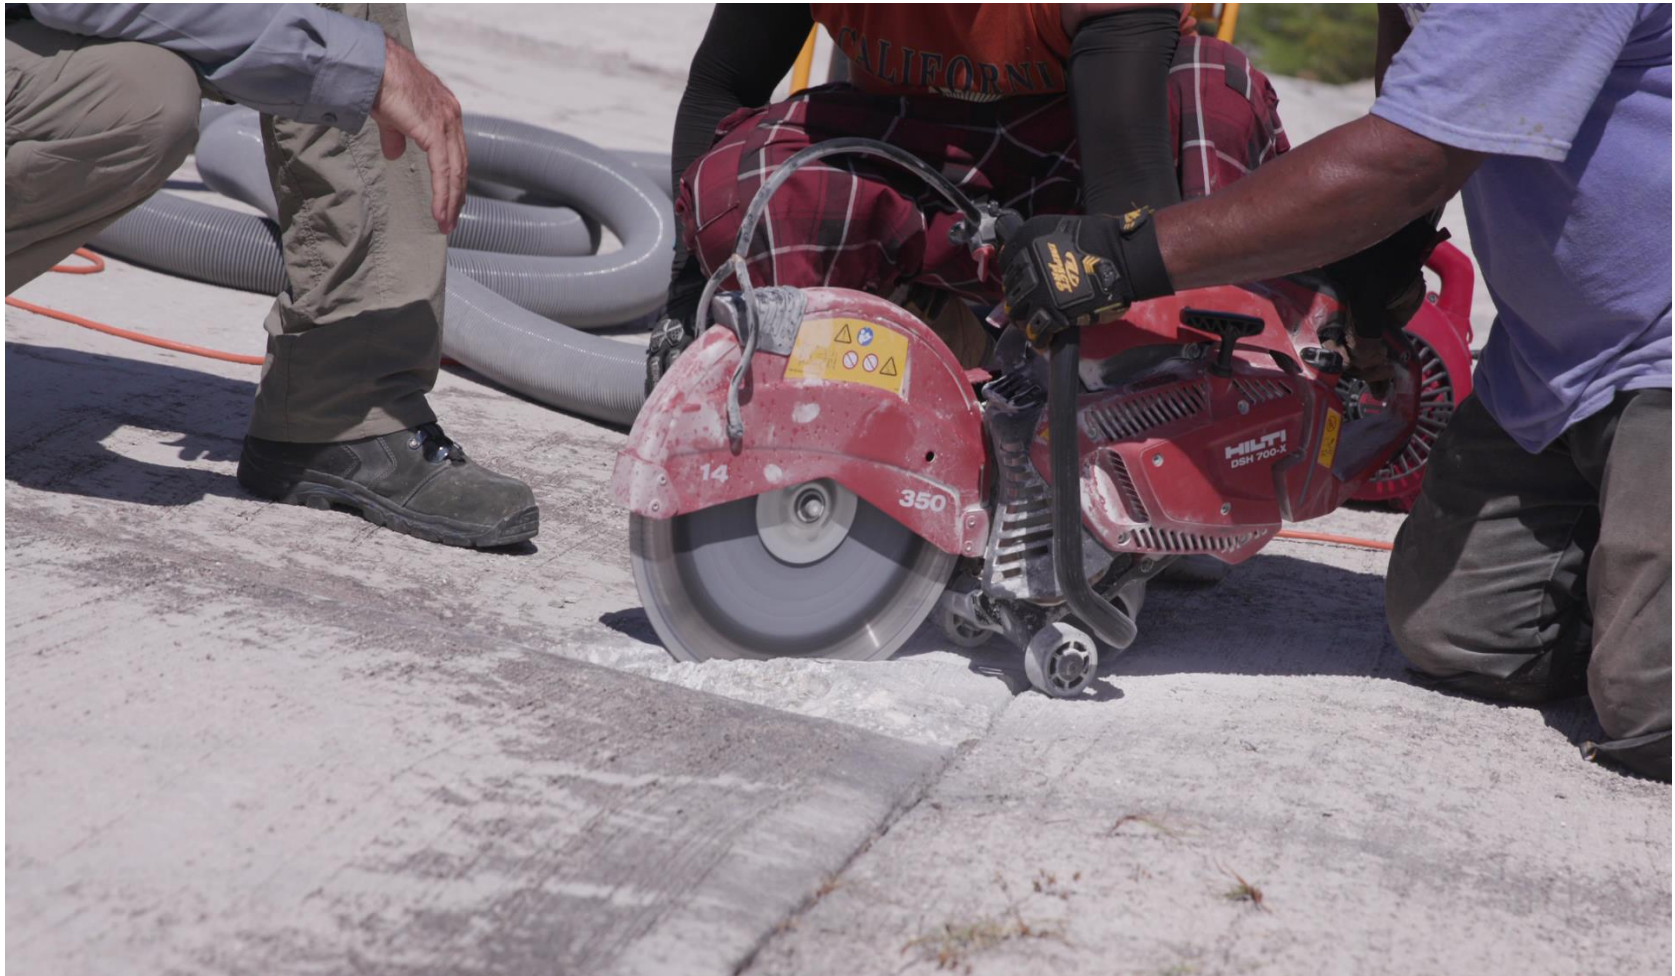
**Concrete Repair Operations Cactus Crater Containment Structure  
(October 2018)**
